# **Teardown Evaluation of Areas of Interest From the T-34A N141SW Aircraft Wreckage**

March 2006

DOT/FAA/AR-TN05/57

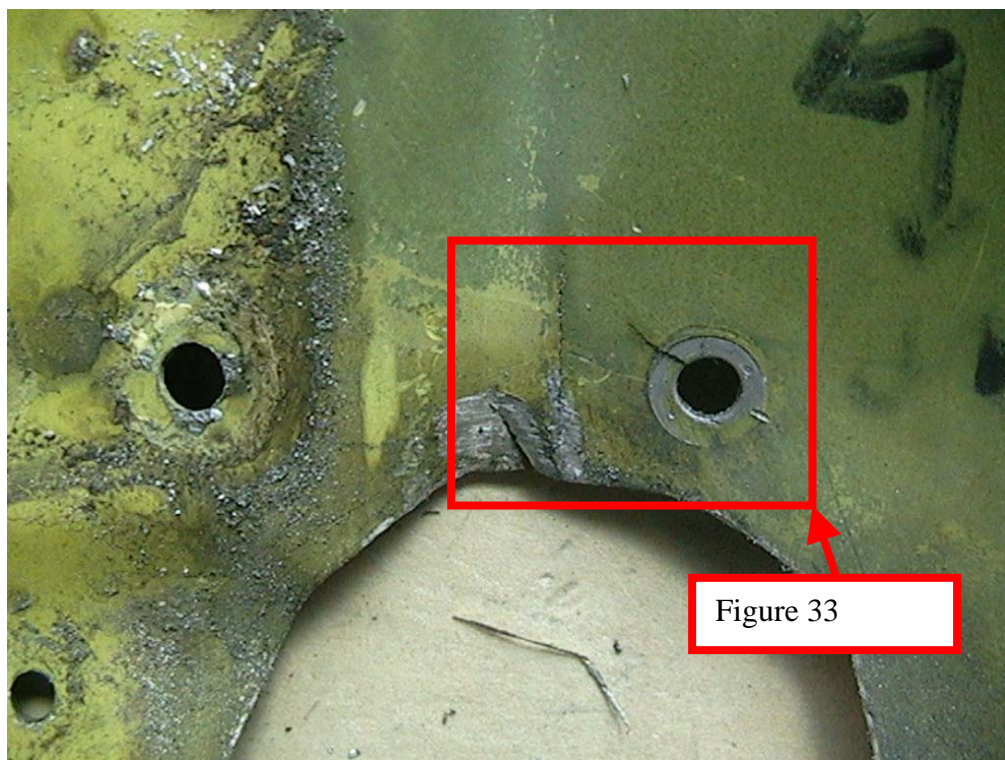
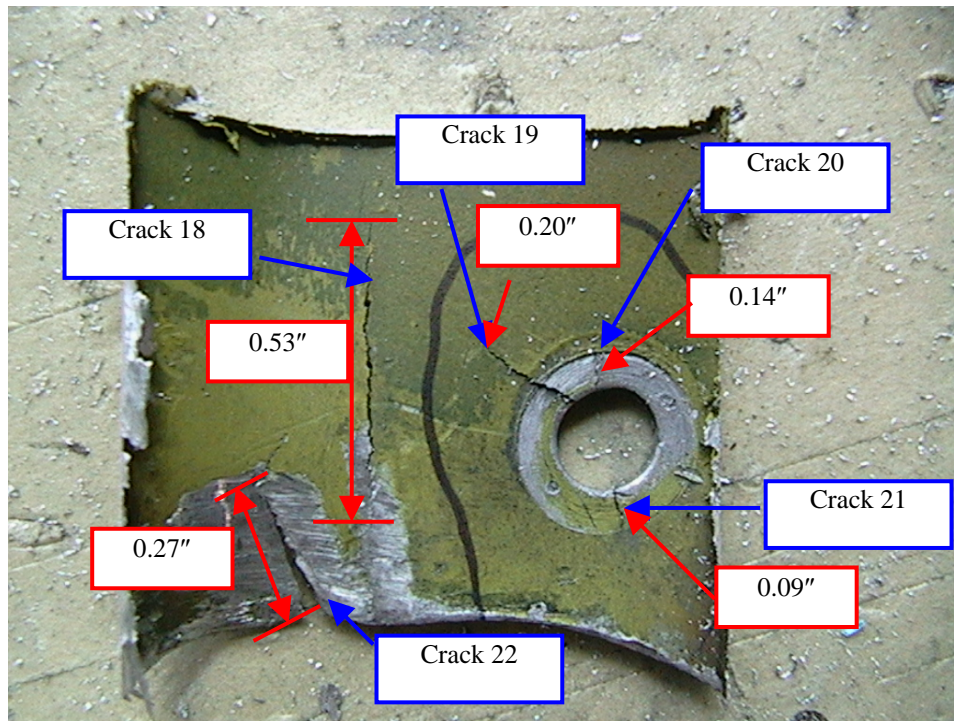
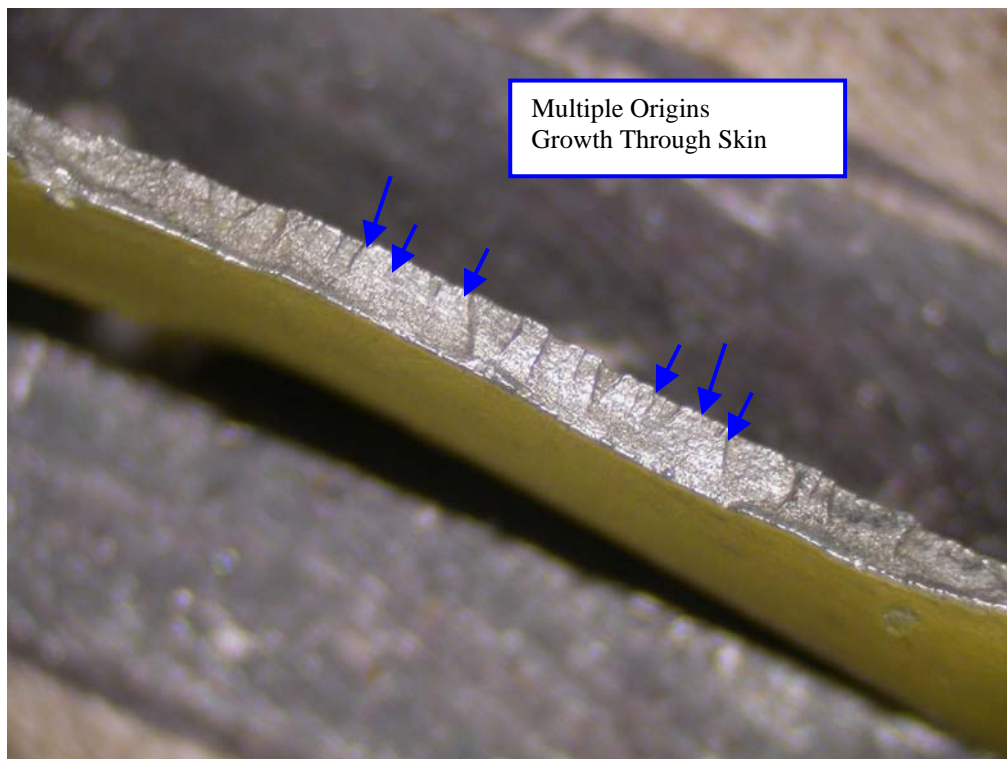
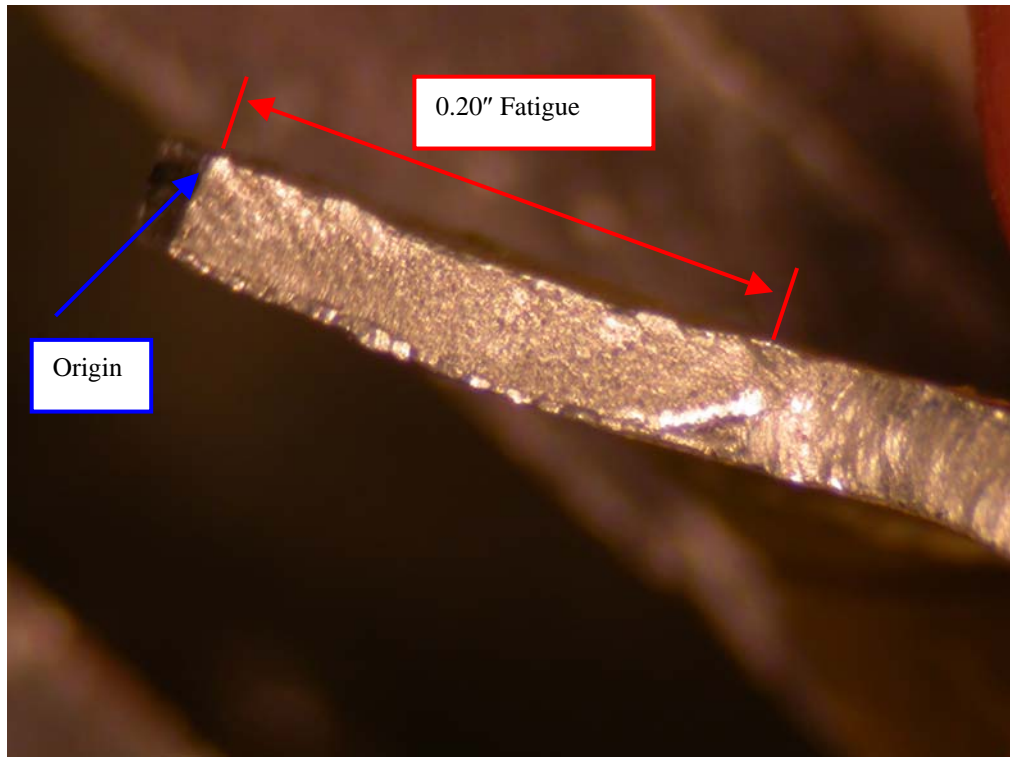
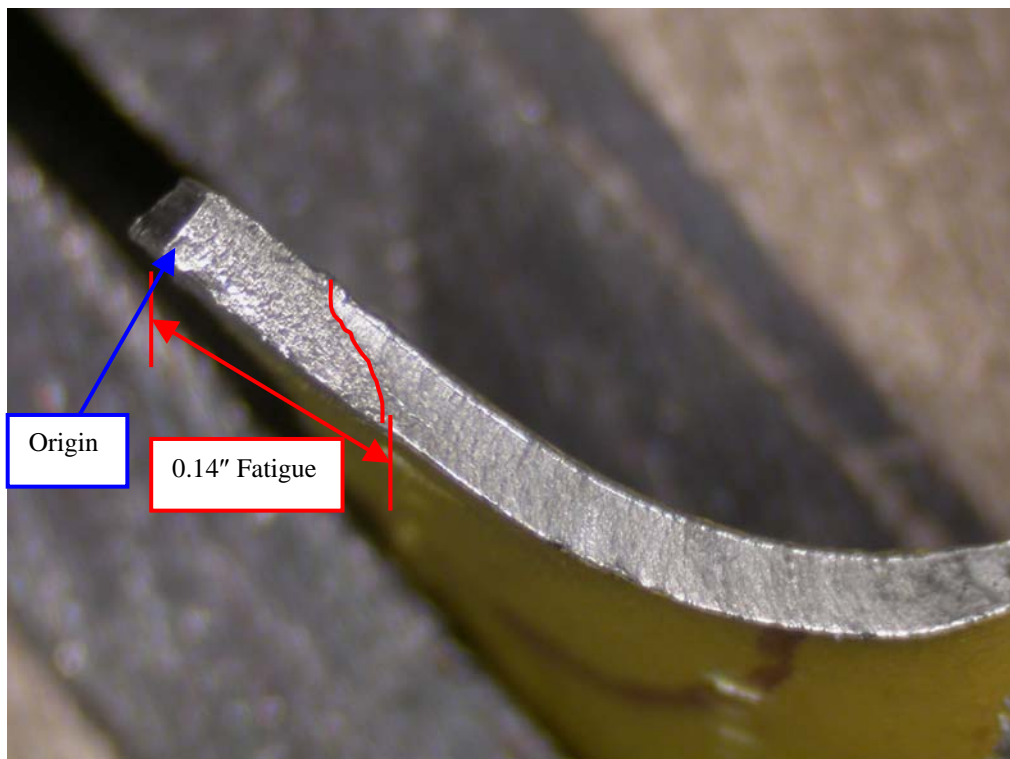
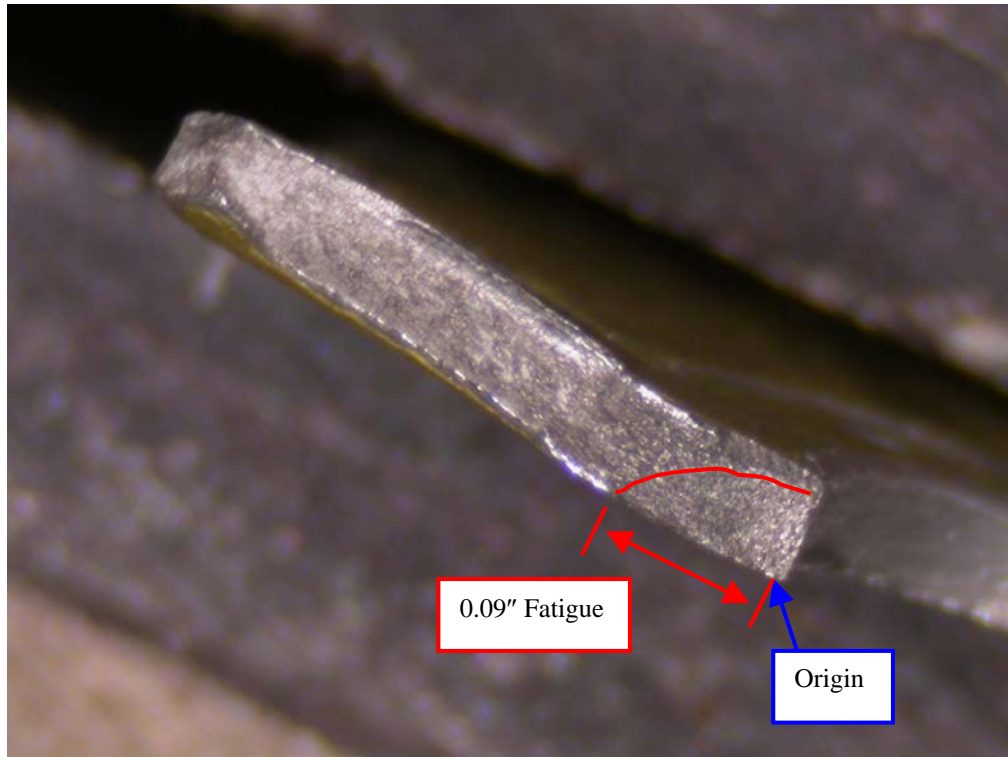
Figure 32 shows an overview of the locations of cracks 18-22, while the location of each crack is shown in greater detail in figure 33. Crack 18 had a total length of 0.53 inch, and the entire crack was caused by fatigue. The crack had origination points starting at the aft side of the web skin and did not grow into or out of any fastener holes. The fatigue did extend through the entire thickness at times, but not for the entire length of the crack. The fracture face for crack 18 is shown in figure 34. Crack 19, measuring 0.20 inch in length, was also caused solely by fatigue and originated from the fastener hole on the forward side of the web skin. Figure 35 shows the fracture face for crack 19. The fracture face for crack 20 is shown in figure 36. This figure illustrates the location of the origin of the crack as well as the shape of the crack as it propagated. The entire length of the crack, 0.14 inch, was caused by fatigue. Figure 37 shows the fracture face of crack 21, including the shape of the crack face as it propagated in fatigue a total length of 0.09 inch. Figure 37 also illustrates the location of the origin of crack 21. Crack 22 measured 0.27 inch and failed due solely to overload.

FIGURE 32. LOCATIONS OF CRACKS 18-22 ON THE RIGHT WING FRONT SPAR CARRY-THROUGH MIDDLE LAYER AFT SIDE WEB SKIN

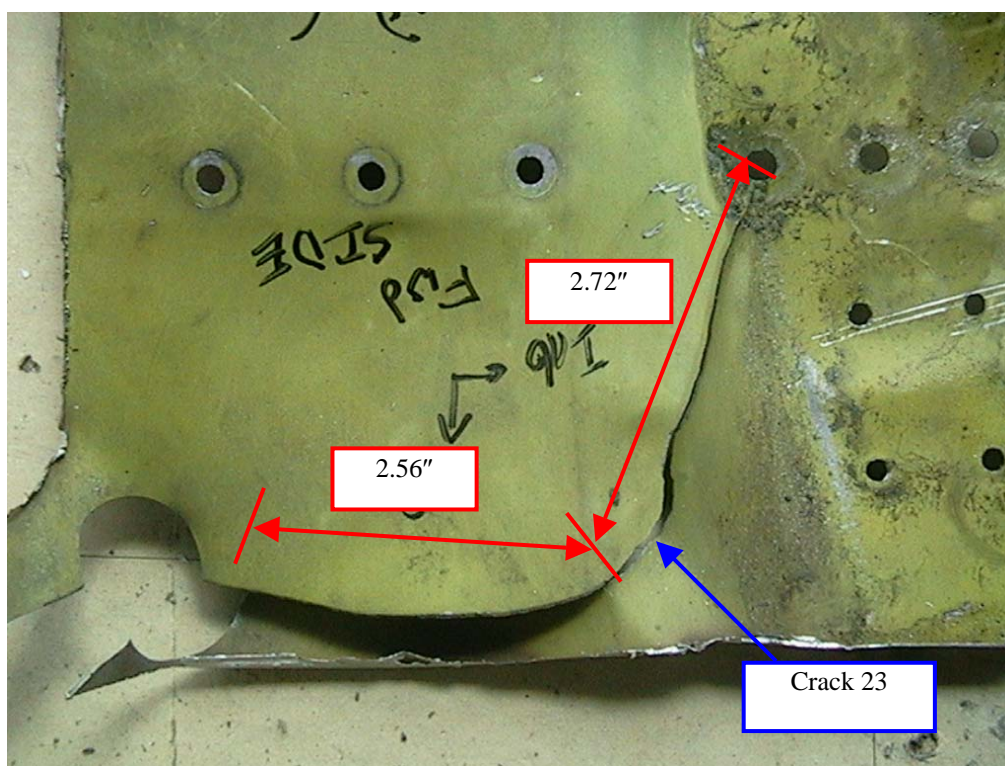
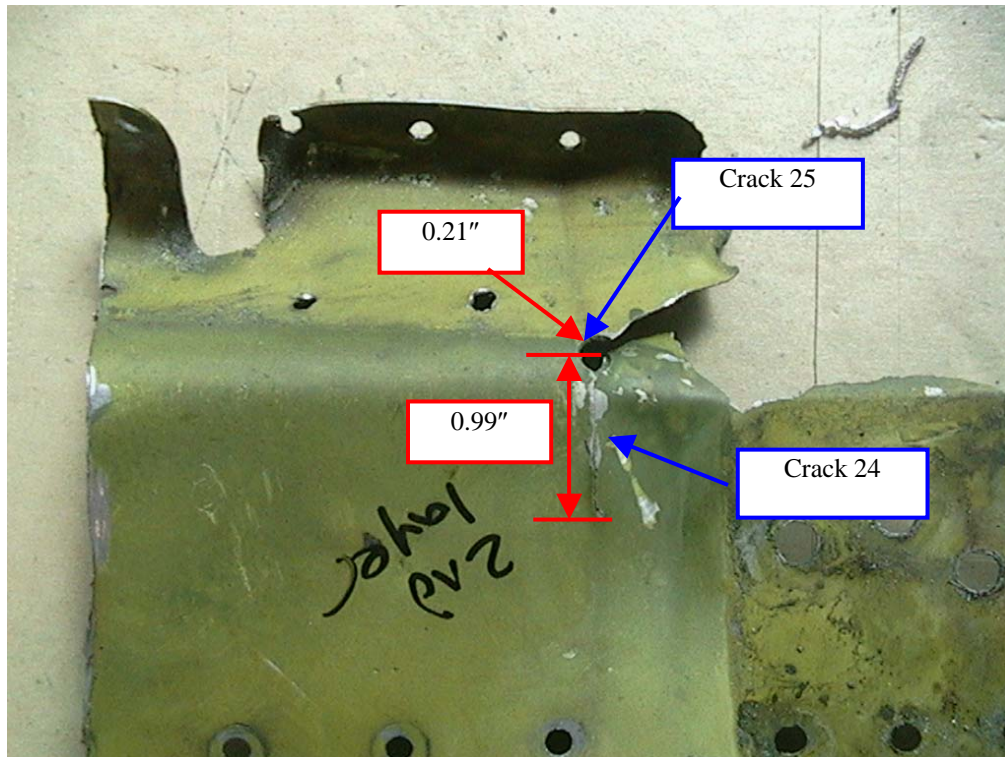
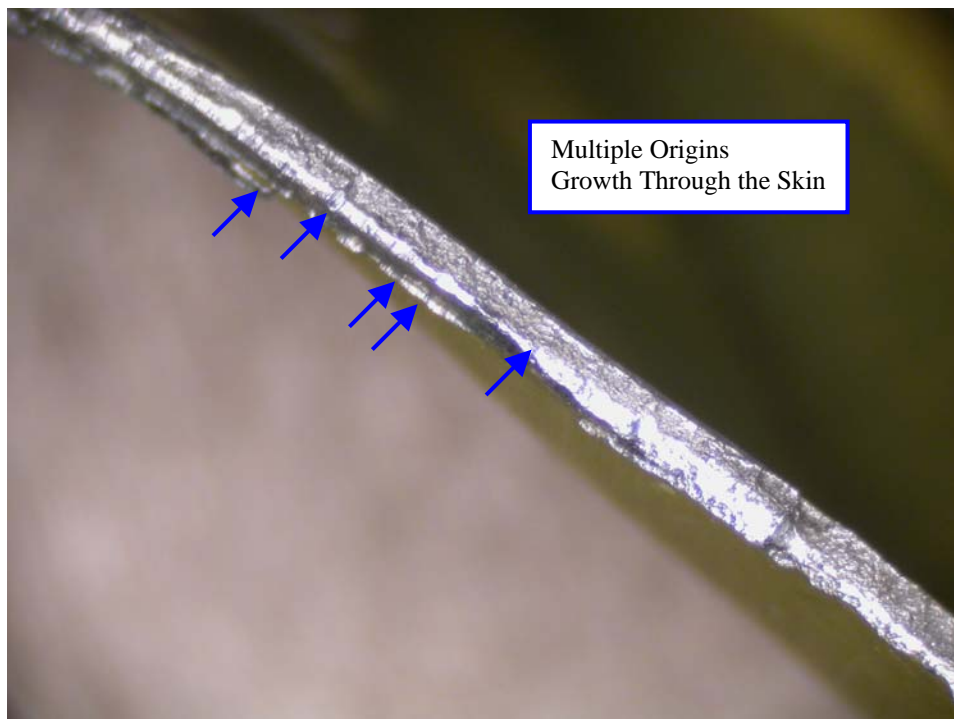
Figure 38 shows the right wing front carry-through forward side stackup. Figure 39 shows the location of crack 23, which had a total length of 5.28 inches and was caused solely by overload. Figure 40 shows the locations of cracks 24 and 25. Crack 24 had a total length of 0.99 inch with a fatigue length of 0.79 inch. This crack had fatigue origins from the forward side of the web skin. The fracture face for crack 24 is shown in figure 41. Crack 25 had a total length of 0.21 inch, with an initial fatigue length of 0.18 inch. This crack had similar origination points as crack 24, and both cracks were though the thickness at some points but not for the entire length of the crack. The faces of cracks 24 and 25 were severely damaged from rubbing against each other, which makes it difficult to identify individual origins and crack shapes. It is possible that the hole between the cracks is actually a stop-drilled hole, which is an effort to prevent further fatigue crack growth. This idea has not been proven and is only supposition at this point.

FIGURE 39. LOCATION OF CRACK 23 ON THE RIGHT WING FRONT CARRY-THROUGH MIDDLE LAYER FORWARD SIDE WEB SKIN

FIGURE 40. LOCATIONS OF CRACKS 24 AND 25 ON THE RIGHT WING FRONT CARRY-THROUGH MIDDLE LAYER FORWARD SIDE WEB SKIN

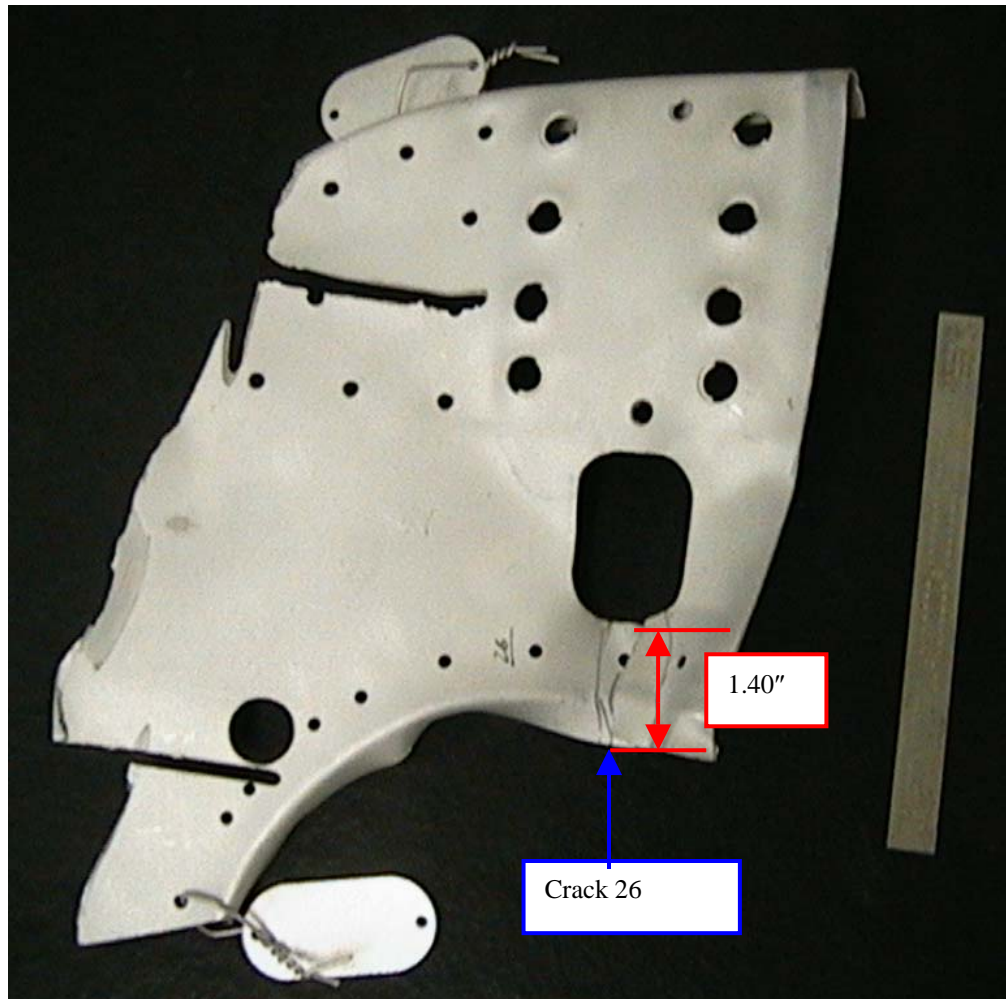
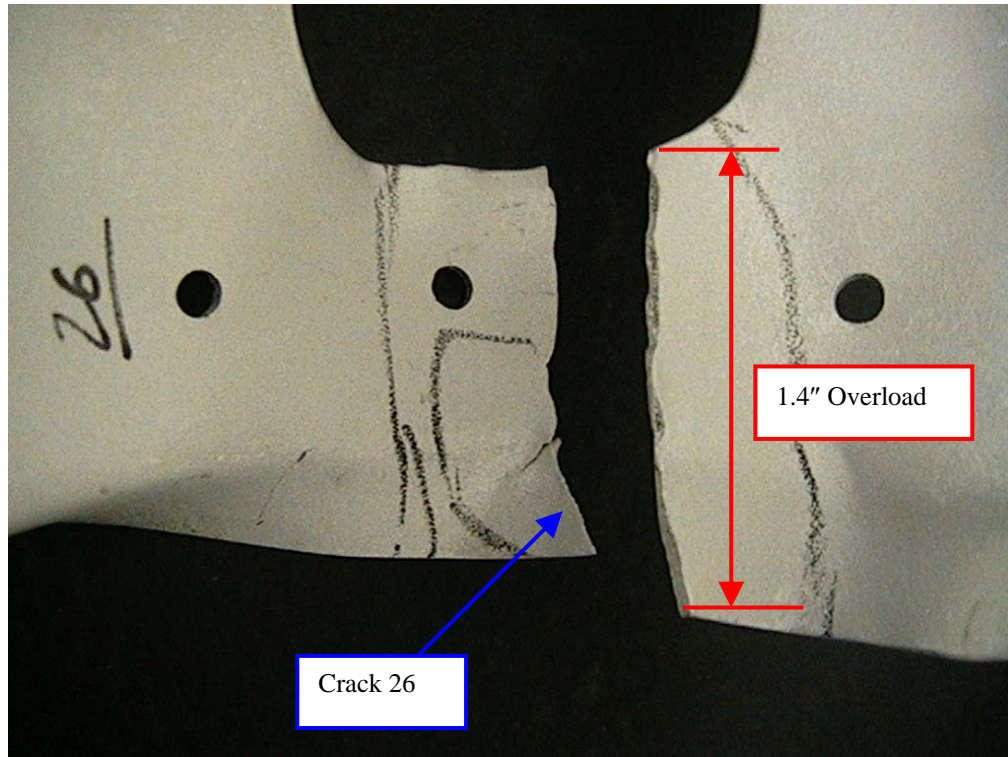
Following the extraction and disassembly of the four areas of interest, a fluorescent liquid penetrant inspection was performed on the horizontal and vertical stabilizer attachment points in conjunction with the microscopic examination in an effort to find smaller cracks in the surrounding structure. Ten cracks were found on the vertical and horizontal stabilizer bulkheads. Figure 42 shows the location of crack 26 in the vertical stabilizer bulkhead top layer. Crack 26, shown in figure 43, had a total length of 1.4 inches, was through the thickness, and was caused solely by overload.

FIGURE 42. LOCATION OF CRACK 26 IN THE VERTICAL STABILIZER BULKHEAD TOP LAYER

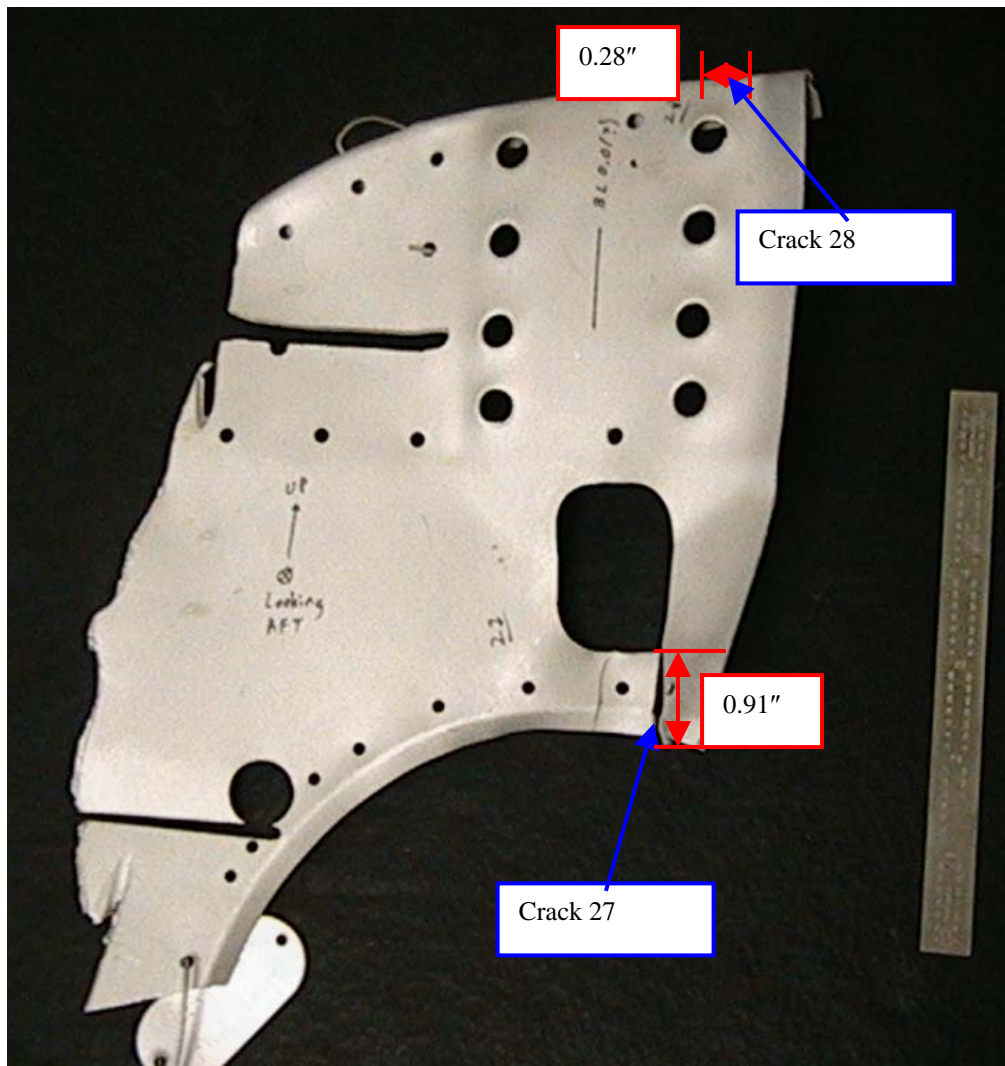
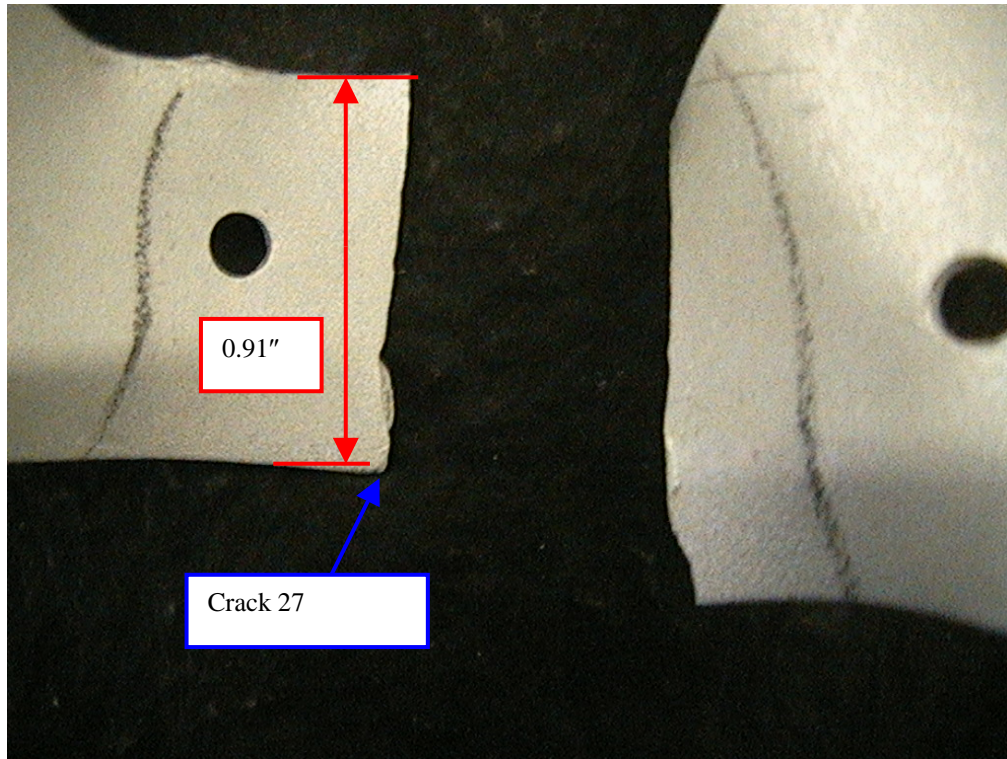
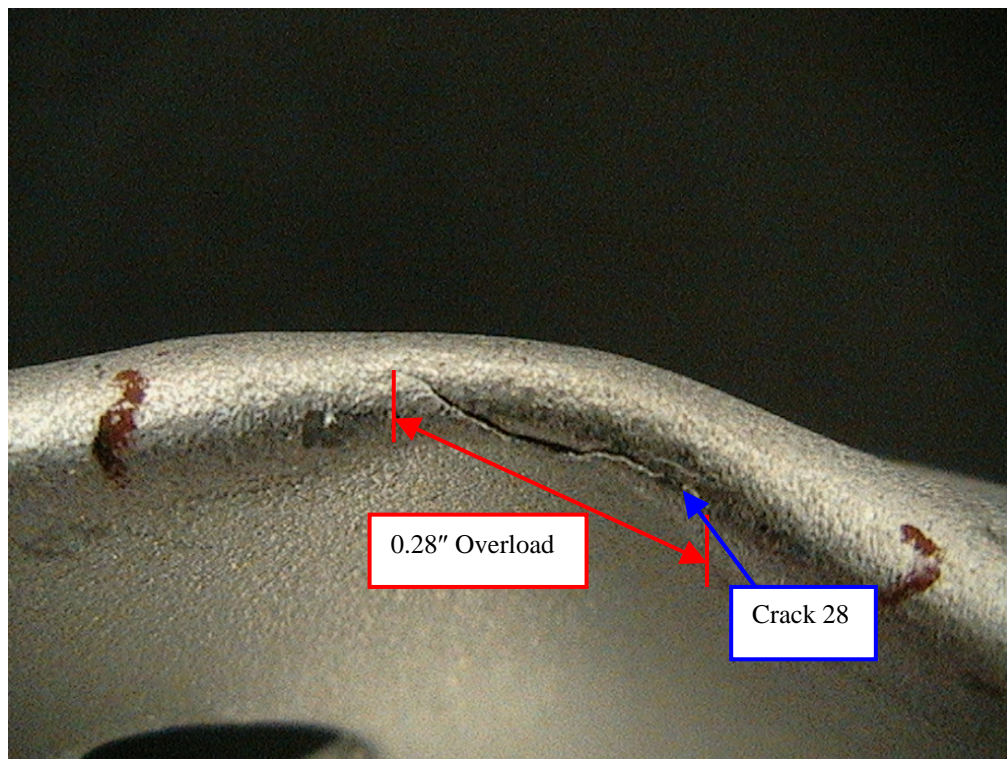
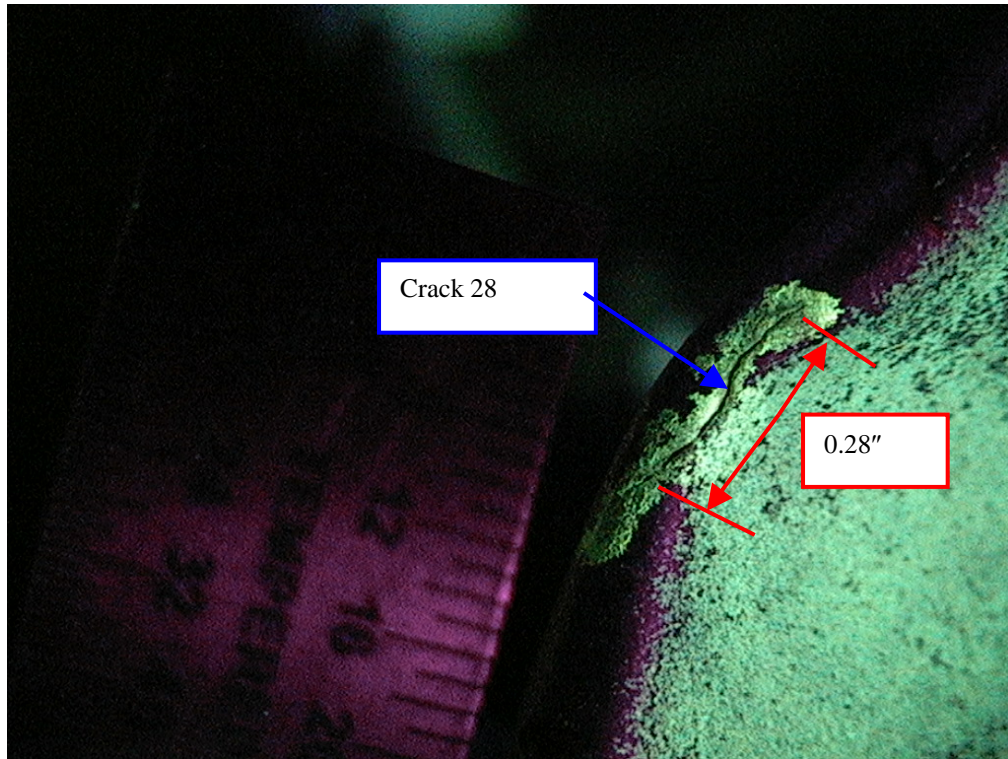
Figure 44 shows the locations of cracks 27 and 28 in the vertical stabilizer bulkhead middle layer. Crack 27, shown in figure 45, had a total length of 0.91 inch and was caused solely by overload, while crack 28 had a total length of 0.28 inch and was also caused by overload. Crack 28 was though the thickness and is shown in figure 46. Crack 28 is also shown in figure 47 during the fluorescent liquid penetrant inspection.

FIGURE 44. LOCATIONS OF CRACKS 27 AND 28 IN THE VERTICAL STABILIZER BULKHEAD MIDDLE LAYER

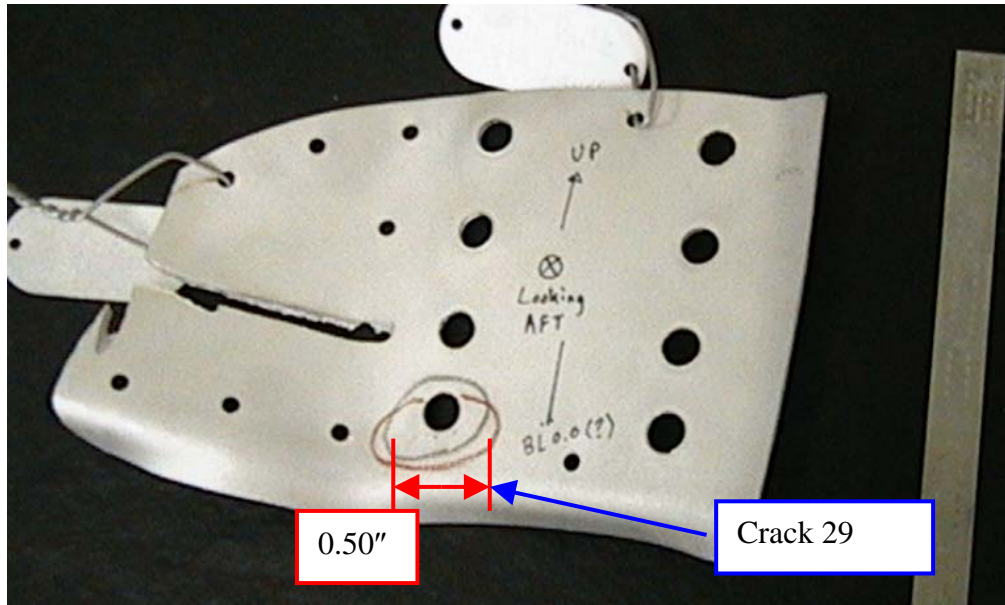
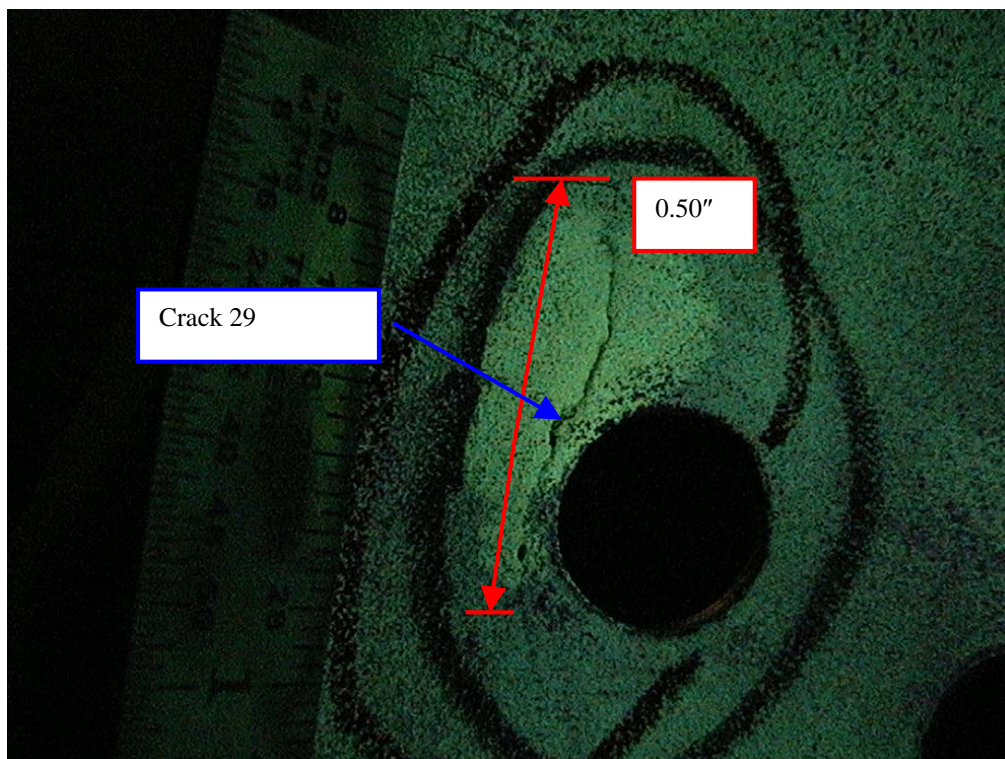
Crack 29 was located on the vertical stabilizer bulkhead bottom layer and measured 0.50 inch. This crack, shown in figure 48, was caused solely by overload. Figure 49 shows crack 29 during the fluorescent liquid penetrant inspection process. Figure 50 shows the locations of cracks 30, 31, and 32 in the horizontal stabilizer bulkhead top layer. Figure 51 shows crack 30, which had a total length of 0.13 inch, was through the thickness, and was caused solely by overload. A picture of this crack under ultraviolet light is provided in figure 52. Crack 31, shown in figure 53, had a total length of 0.19 inch and was caused by overload. Figure 54 shows crack 31 under ultraviolet light during the fluorescent liquid penetrant inspections. Overload was also the only failure mechanism observed on crack 32, shown in figure 55. Crack 32 had a total length of 1.13 inch. Figure 56 shows the crack during the fluorescent liquid penetrant inspection process.

FIGURE 48. CRACK 29 IN THE VERTICAL STABILIZER BULKHEAD BOTTOM LAYER

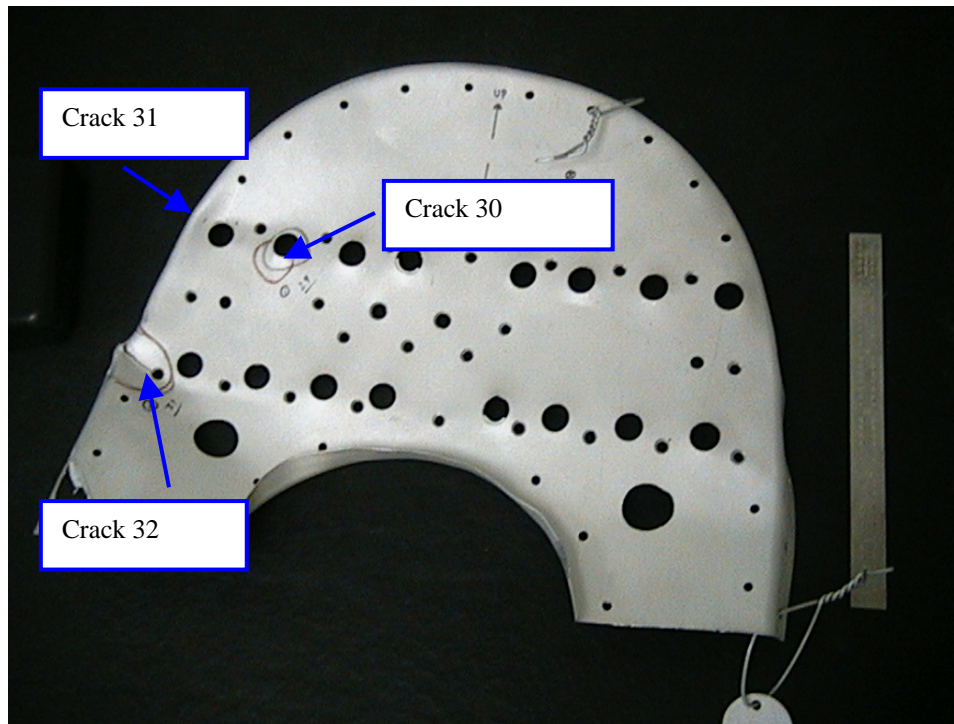
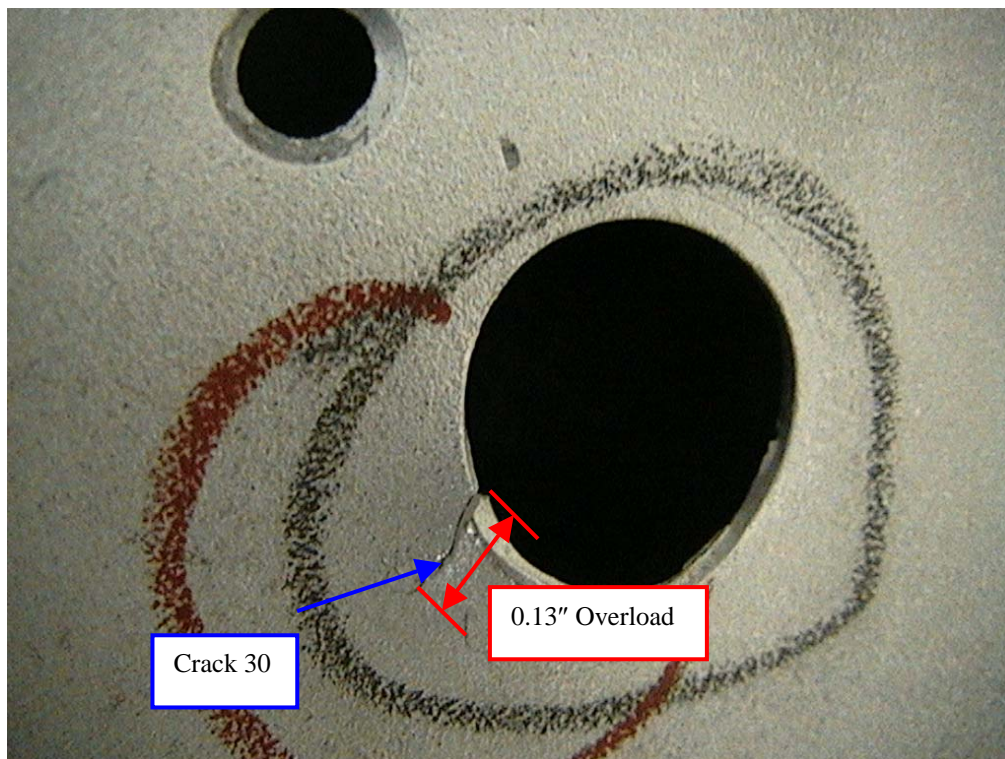
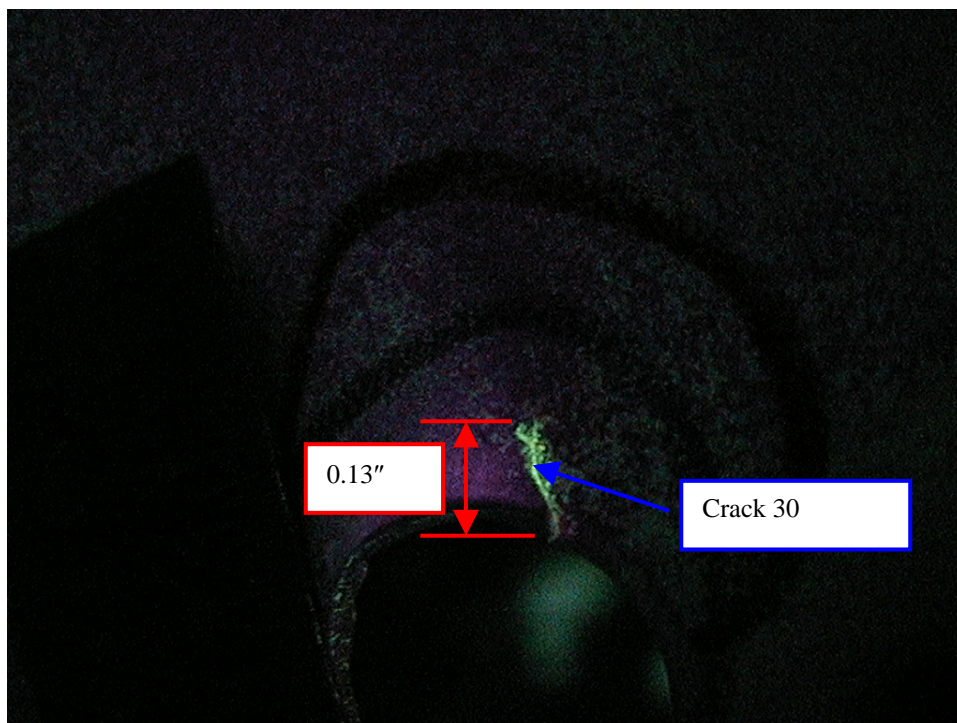
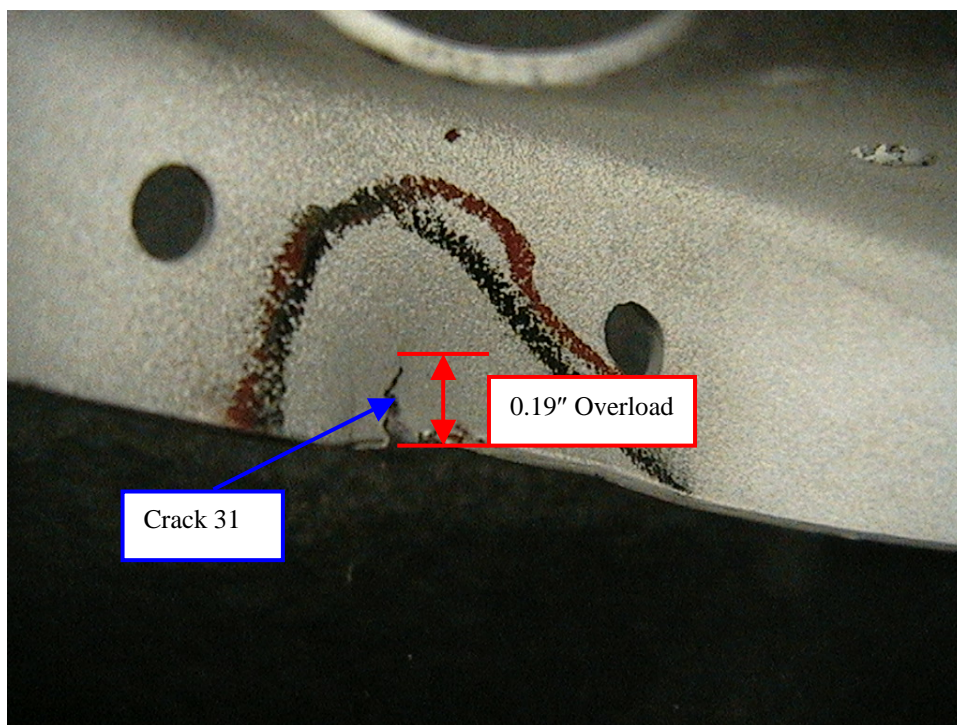
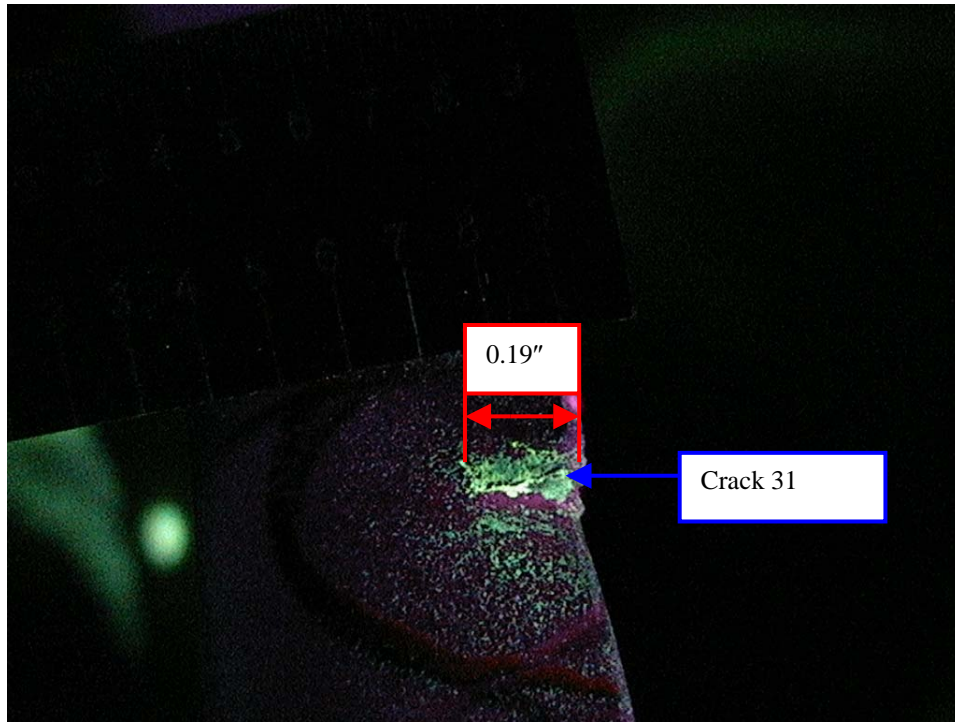
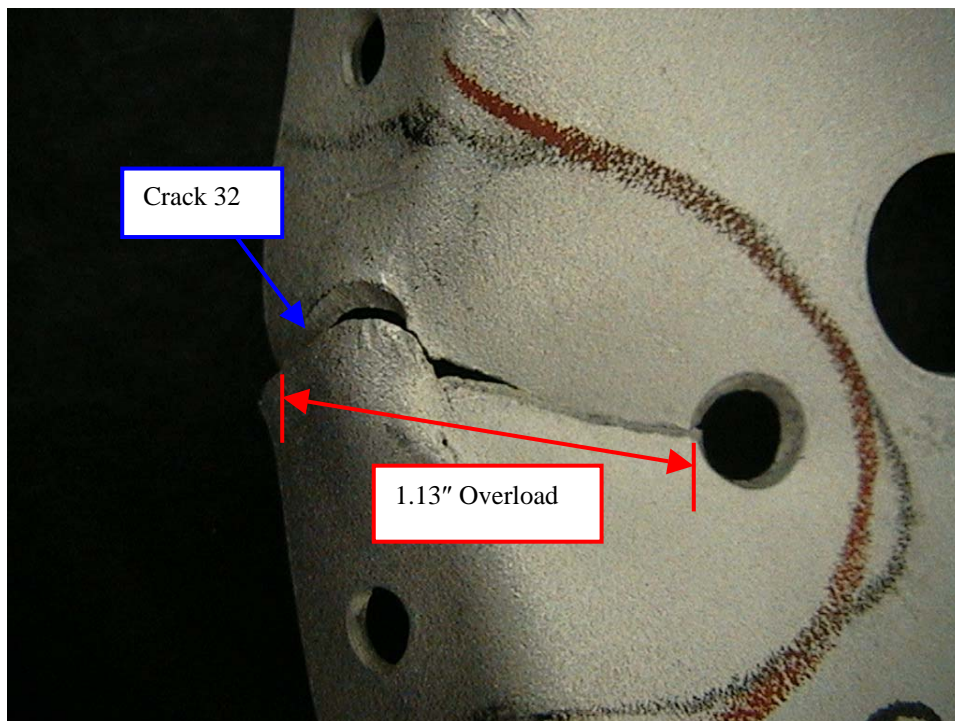
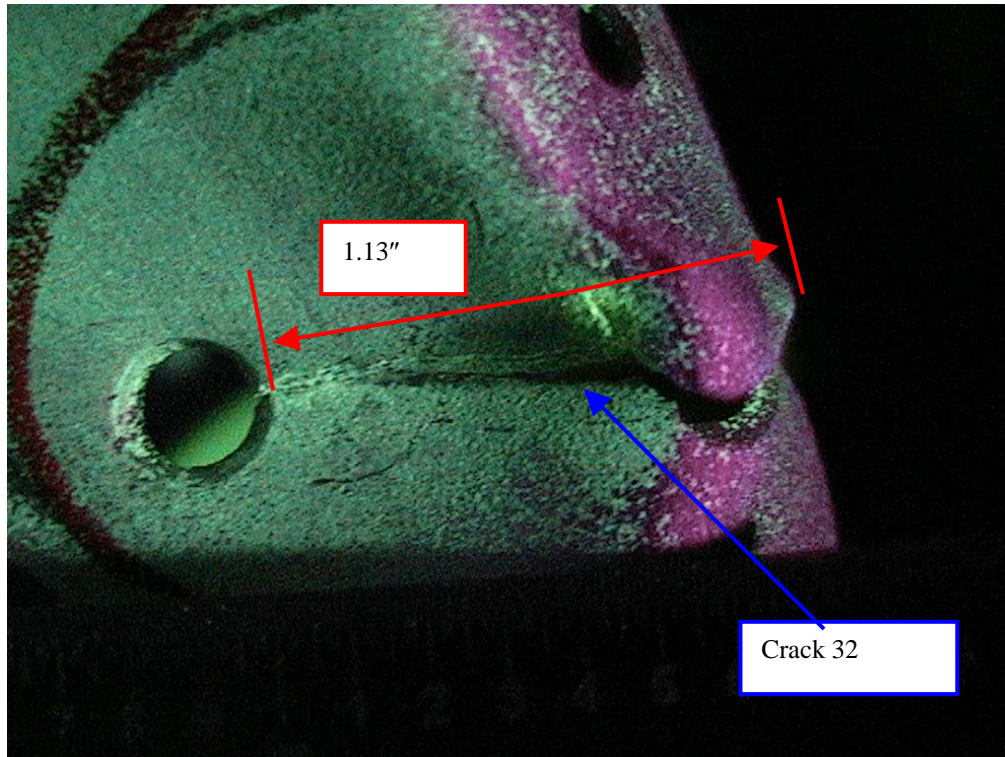
FIGURE 50. LOCATIONS OF CRACKS 30, 31, AND 32 IN THE HORIZONTAL STABILIZER BULKHEAD TOP LAYER
